PRELIMINARY

FY 2010

**NON-ROUTINE
MAINTENANCE
LIST**

May 22, 2008

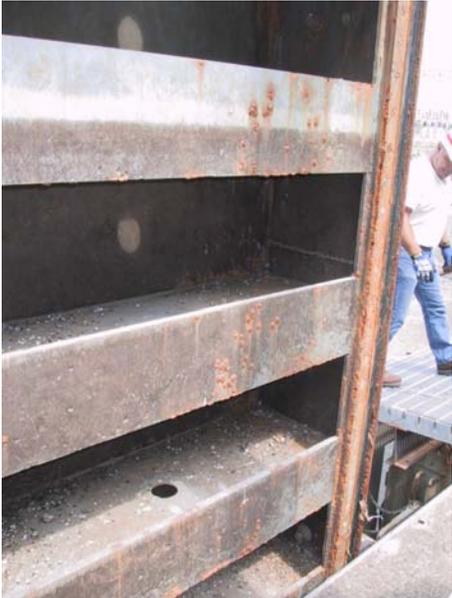
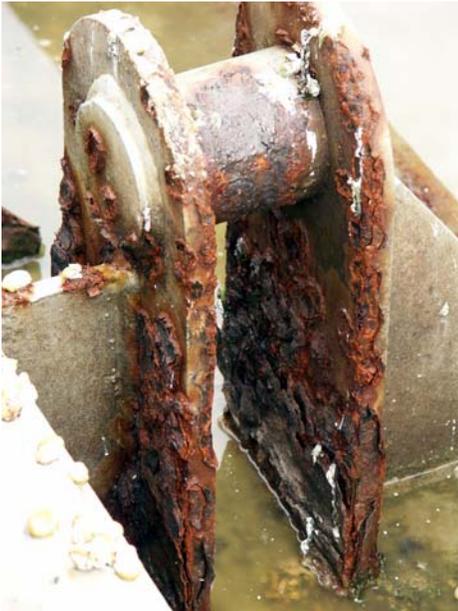
History of Outages/Deficiency: The intake and draft tube gate paint system is failing due to age which is leading to structural deterioration of the gates. The existing paint on the gates is vinyl. The roller chains have pitted rollers and several of the keepers on the pins have failed. In recent years, several rollers have cracked and were replaced. Many of the fasteners have deteriorated and the seals on the gates are in poor condition and must be replaced as part of the project. Numerous areas on the surface of the gates are corroding where the paint system has failed. Deterioration will continue until the gates are repaired. Each of the four intake roller gates are approximately 21'-wide by 40 ft in length, each of the six bulkheads are 20' by 43' and each of six the draft tube gates are 20' wide by 31' in length.

Draft Tube Gate

Solution: Sand blast the intake and draft tube gates, make any required structural repairs, repaint with an acceptable paint system, repair or replace all roller chains where required, and replace all seals and bolts on all of the gates.

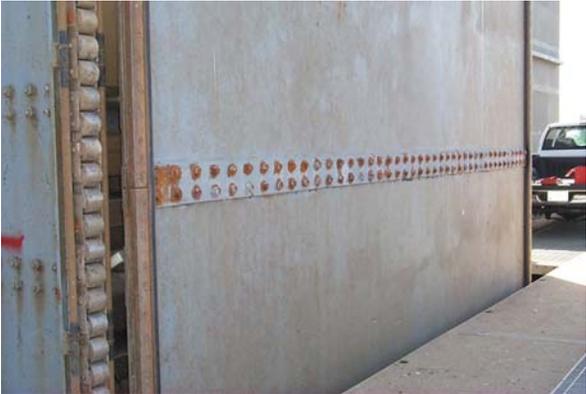
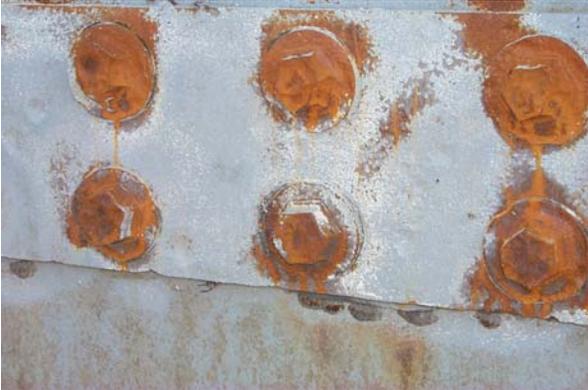
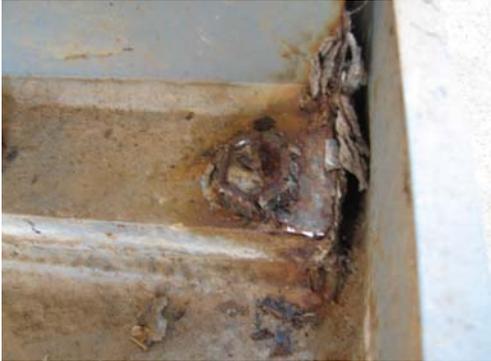
Intake Gate

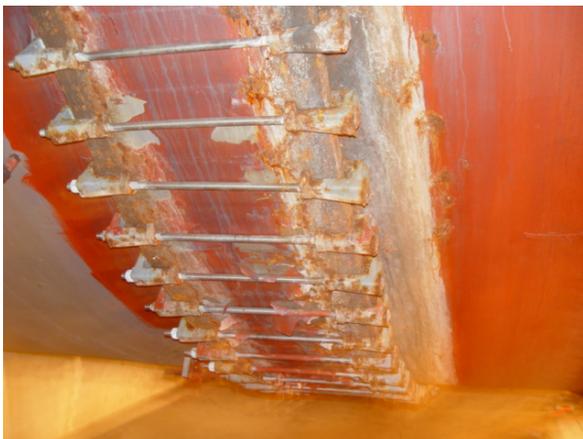
History of Outages/Deficiency: The existing expansion joints on the penstocks have deteriorated with rust and corrosion. In addition the paint system on the penstock has failed. Deterioration will continue until rehabilitation is performed will increase the rate of water leakage, corrosion and metal loss. The penstock is constructed of riveted joints and rivets are corroding.

Penstock Expansion Joint

Solution: Sandblast inside and outside of penstocks in vicinity of the expansion joint, repair the expansion joints, repair damage rivets and repaint.

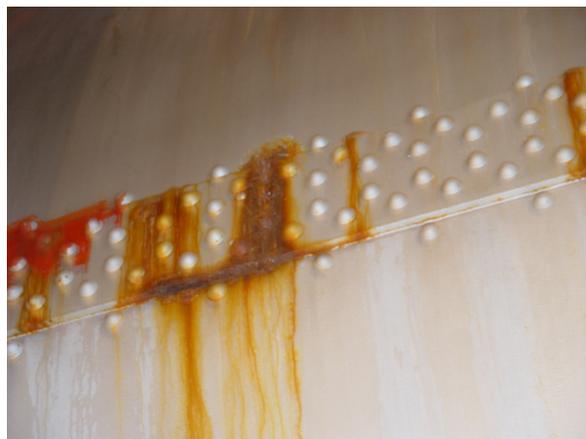
- The corrosion protective coating has failed resulting in metal loss
- The expansion joint leaks adding to the corrosion problem and requires the sump pumps to operate more often
- Continued deterioration of the rivets could result in more severe leakage or flooding

Penstock Deterioration and Leakage

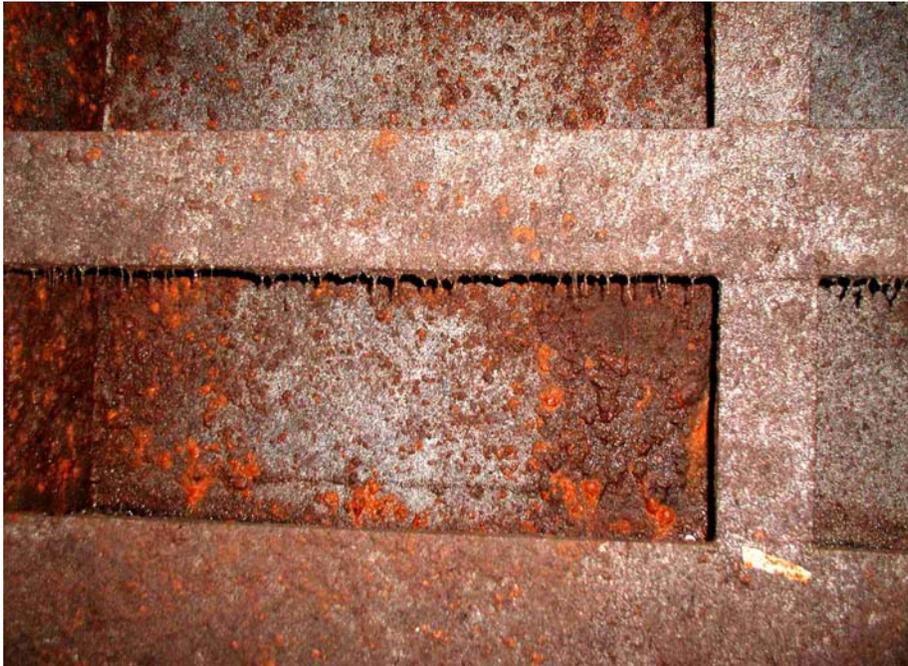
VIEW OF RUST ON STRUCTURE OF INTAKE GATE

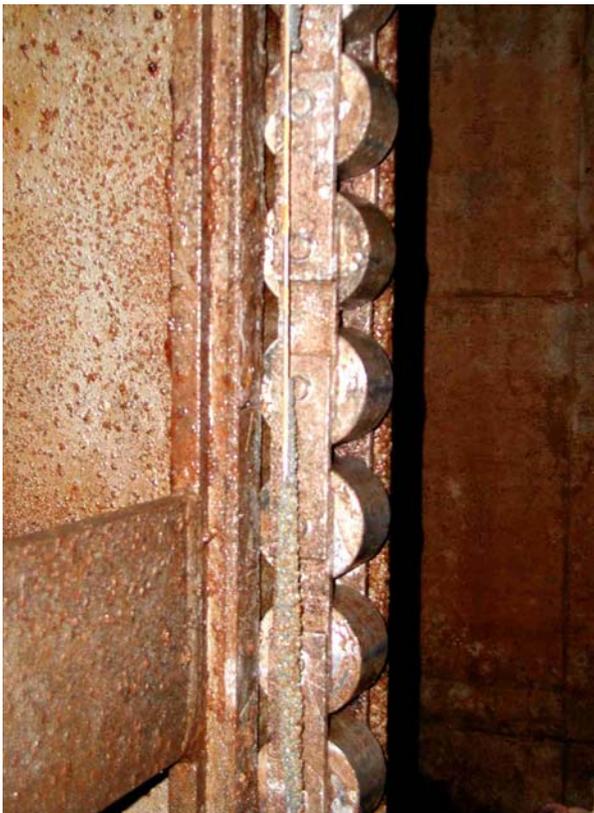
VIEW OF RUST AND DETERIORATED INTAKE GATE ROLLER CHAINS

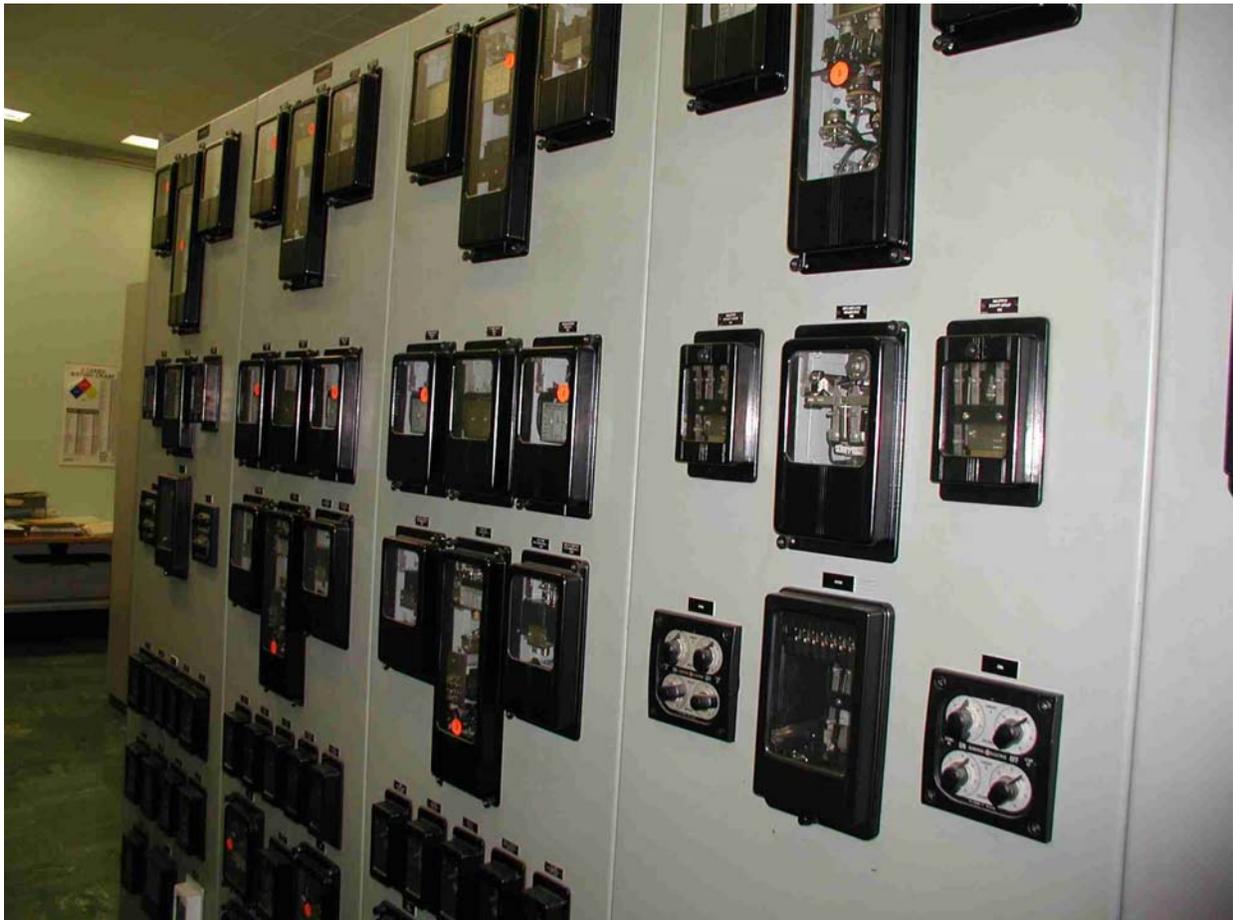
- Safety and reliability of the equipment is jeopardized by failure of the relays to detect and respond to critical alarms, resulting in loss of power generation capabilities.
- Possible loss of 19.5 MW of generating capacity.
- Probable extended outage time of six weeks due to failure of equipment.
- Standardization of control scheme will facilitate centralizing remote control at the RS Kerr powerhouse.
- The relays to be replaced were installed approximately 50 years ago. They require frequent maintenance and adjustments. Modern relays require less maintenance.

Protective Relays Panels

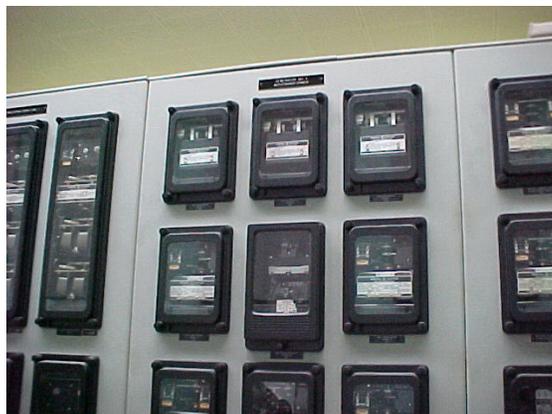
- Safety and reliability of the equipment is jeopardized by failure of the relays to detect and respond to critical alarms, resulting in loss of power generation capabilities.
- Probable extended outage time of six weeks due to failure of equipment.
- The relays to be replaced were installed approximately 35 years ago. They require frequent maintenance and adjustments.

Protective Relays Panels

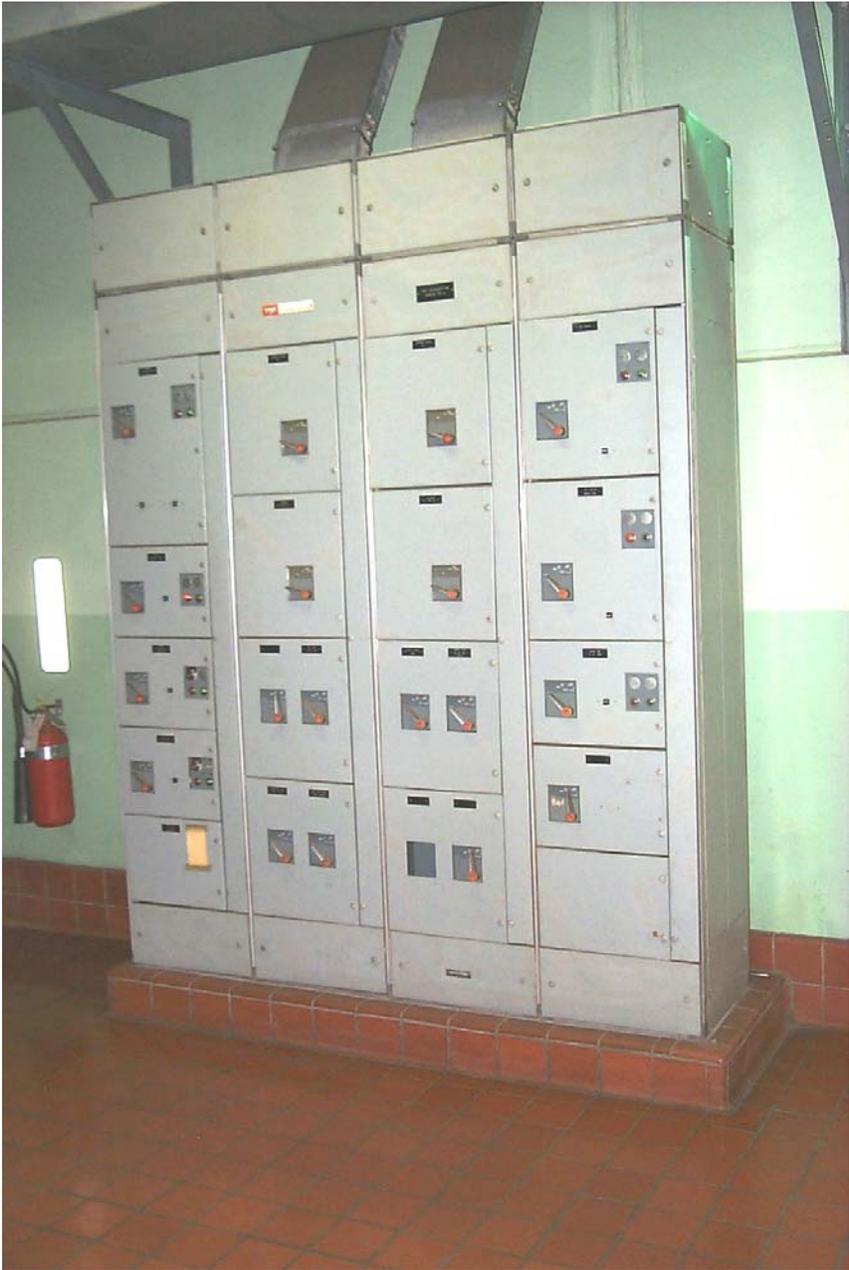
- Catastrophic failure of one of the molded case circuit breakers could result in injury to operation and maintenance personnel.
- An extended outage of one month is possible to get rebuilt replacement parts or to repair or to replace the entire panel.
- Due to the age of the equipment, replacement is necessary.
- New replacement breakers do not match with door cutouts.
- Distribution center provides power to critical auxiliary equipment such as generator thrust bearing oil pumps, governor oil pumps and excitation equipment.

Robert S. Kerr Motor Control Center

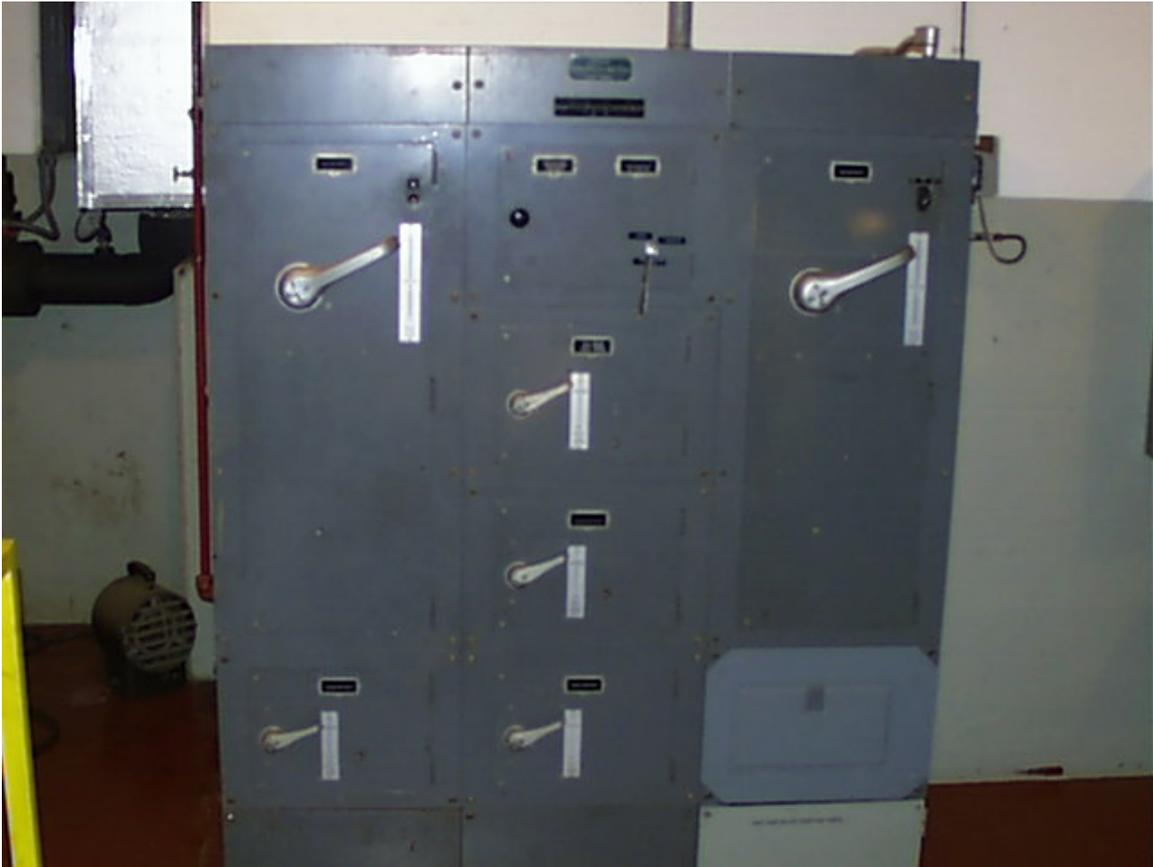
- The existing MCCs are underrated and pose a hazard to both equipment and personnel.
- The existing MCCs are obsolete and cannot be properly maintained due to unavailability of spare parts.
- Loss of critical breakers could result in loss in ability to generate.

Fort Gibson Motor Control Center

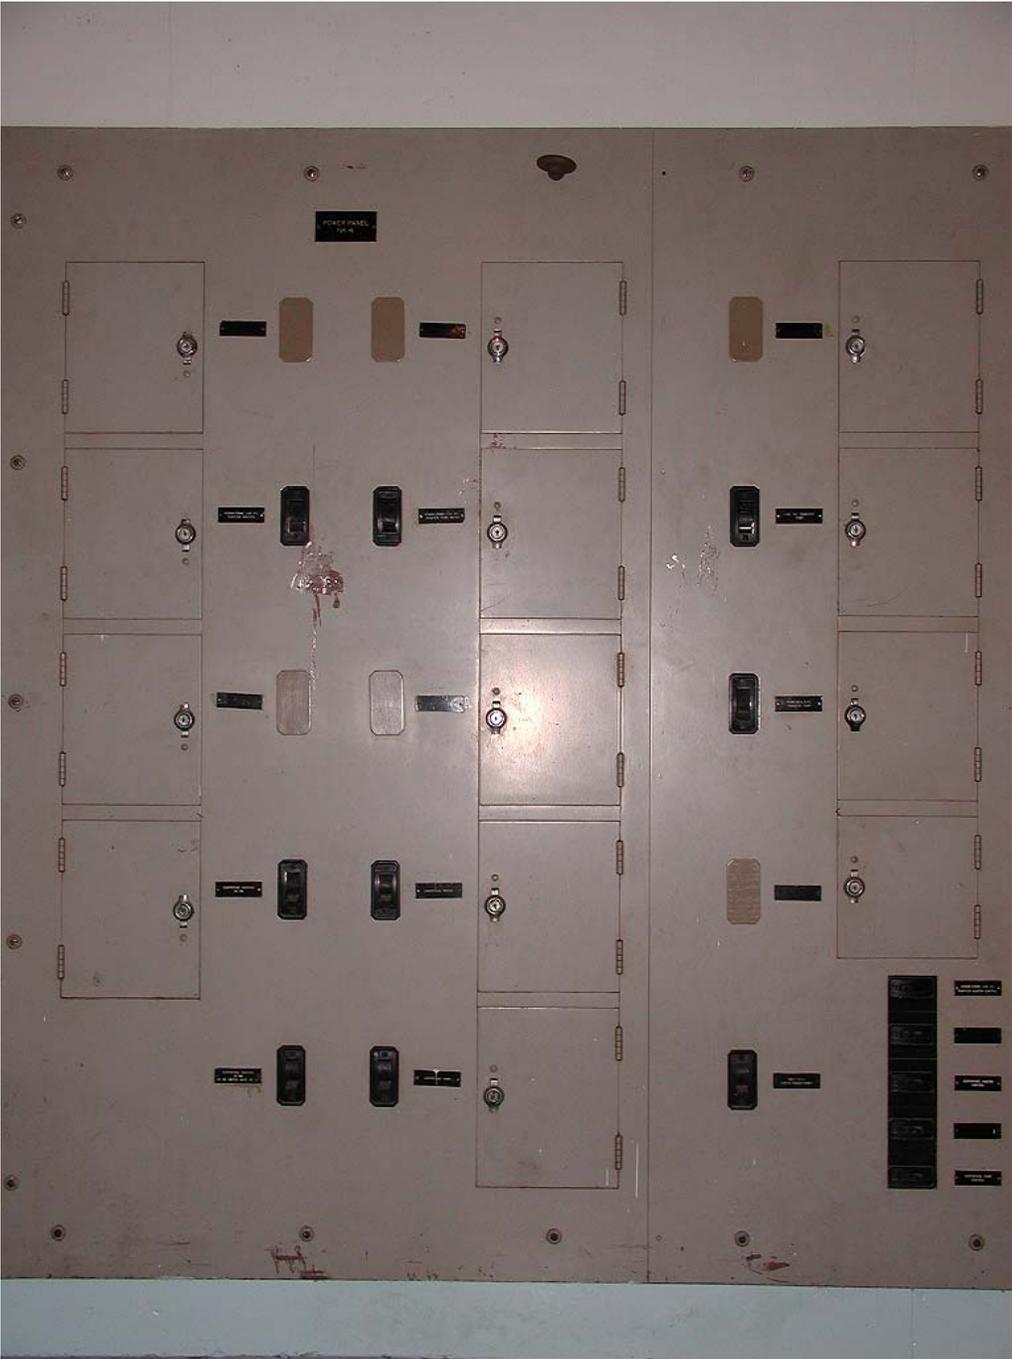
- The existing MCCs are underrated and pose a hazard to both equipment and personnel.
- The existing MCCs are obsolete and cannot be properly maintained due to unavailability of spare parts.
- The existing air compressors are original equipment and require more maintenance than the modern design screw type.

Denison Wall Mounted MCC
