FY 2011

**NON-ROUTINE
MAINTENANCE
LIST**

Information Data Sheet for Customer Funding

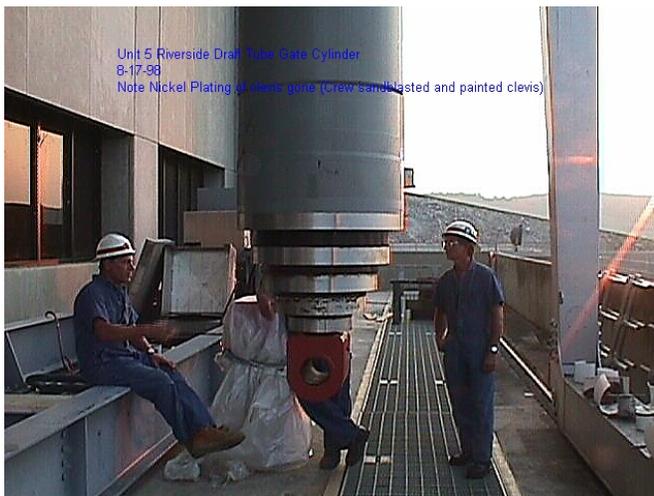
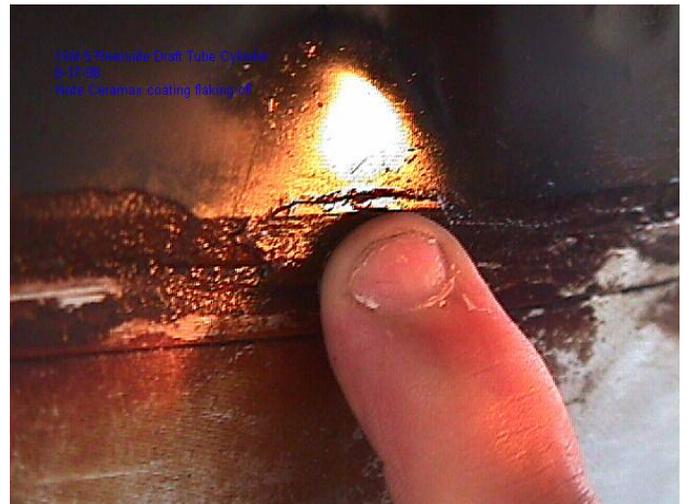
Photographs:

Item Proposed for Customer Funding: Inspection and Repair of Draft Tube Bulkheads, Cylinder Hoists, and Liner and Cavitation Damage.

stems and provides a sealing surface for the cylinders' internal seals and the nickel plating on the eye ends has failed. Continued corrosion of the operating stems will cause the protective ceramic coating to flake off and the hydraulic cylinders will no longer be able to operate and retain hydraulic oil. There is a potential of losing 900 gallons (from one cylinder) of hydraulic oil into the tailrace (Lake of the Ozarks) downstream of the power plant. Cylinder drift and cycling has also become a problem due to leakage past the internal piston seals. The number of cycles per day depends on the individual cylinder and fluid temperature, but some of the cylinders are cycling over 300 times a day to keep the draft tube bulkheads from drifting into the water passageway. Repair of the cylinders and installation of an automatic latching (dogging) mechanism is needed to prevent the bulkheads from drifting into the water passageways.

Solution: The draft tube bulkhead cylinder work will include redesign of the ceramic protective coating system, repair/rebuilding of the hydraulic cylinders with the redesigned ceramic coating system, and design and installation of an automatic dogging mechanism to prevent cylinder drift. **The draft tube bulkheads will be removed from their slots and inspected and repaired in accordance with COE criteria in concurrence with the hydraulic cylinder repair contract to avoid a duplication of work effort.** The anodes on the bulkheads will also be replaced. Cavitation repair and painting of the draft tube liners and turbines will be performed after the draft tube bulkheads cylinders have been repaired and the draft tube bulkheads inspected/repared and certified for service.

Scope of Work: Perform engineering and design to develop a new protective coating system that protects the operating stems and an automatic latching dogging device that prevents cylinder drift. Prepare plans and specifications and advertise/award a contract to repair/rebuild the cylinders and install the dogging devices. COE (Kansas City District) will be responsible for the inspection and repair of the draft tube bulkheads. Work will include a visual inspection of all welds, documentation of inspection results, and repair of any weld and/or structural defects. Inspection and repair work will be performed by contract with COE oversight. Power Plant personnel will be responsible for purchasing and replacing the bulkheads' anodes. Also prepare plans and specifications for cavitation and corrosion repair work, sandblasting, and painting of draft tube liners, discharge rings, turbine runners, blades and wicket gates on all six units. Hired labor will be used to complete cavitation repair work and painting will be completed by contract.
